Templeton-Whitney Grazing Allotments, Golden Trout Wilderness

Head Cut and Photo Point Monitoring, 2003 and 2010 (DRAFT)

By: Casey Shannon, Hydrologic Technician

Inyo National Forest, Supervisor's Office

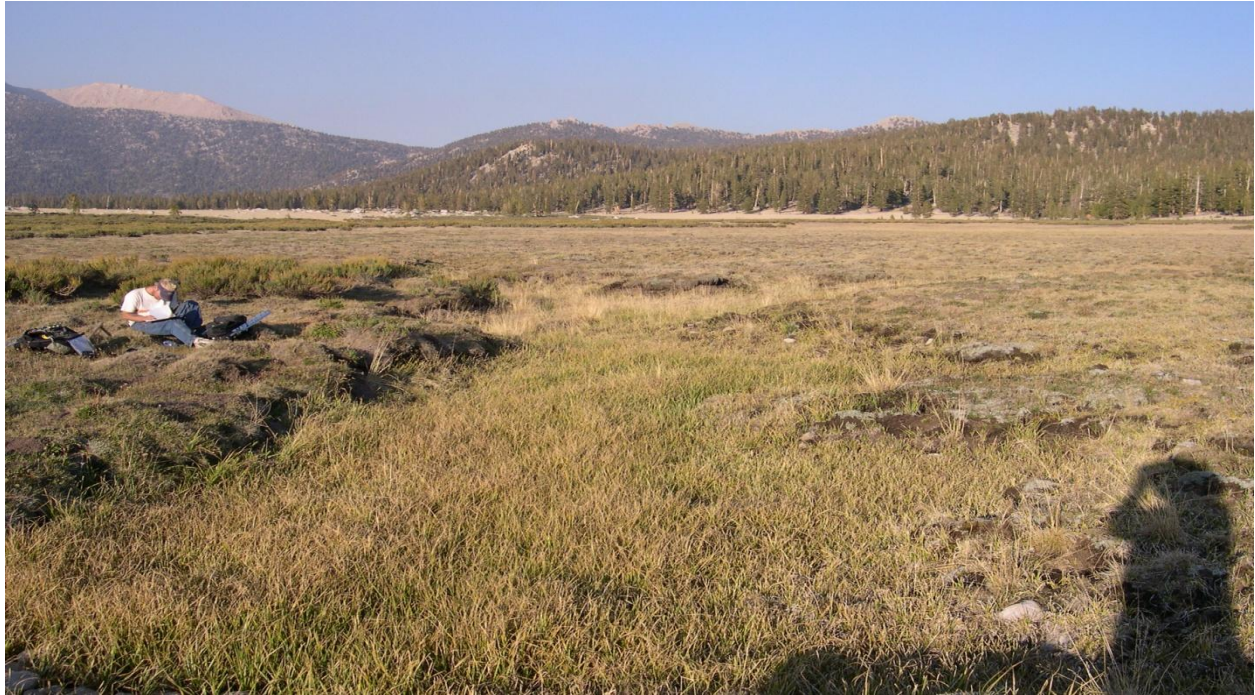
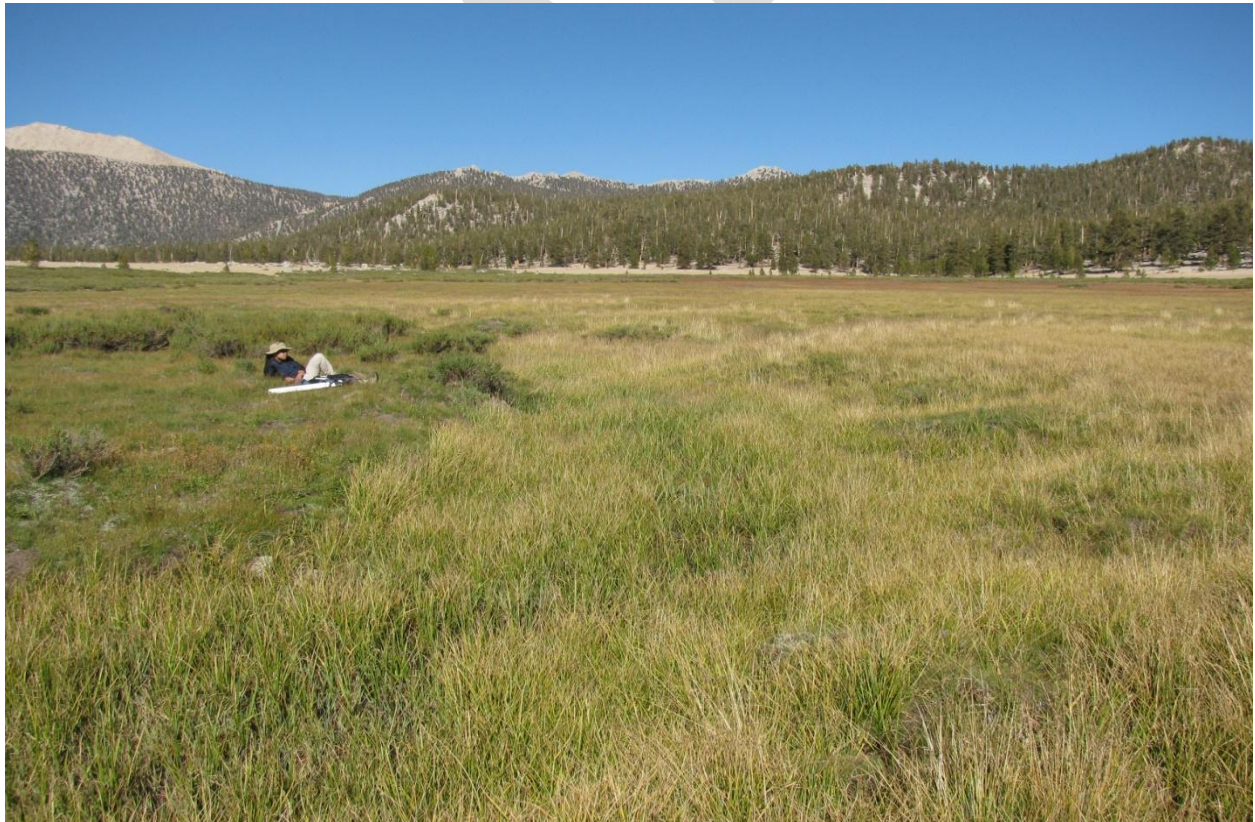
Above photo: Photo point 12 (1999) Big Whitney meadow Section 5, September 2003. Terraces and banks along floodplain channel have widespread, eroded hummocks and bare ground areas, unstable. **Below photo:** PP 12 1999 Big Whitney Meadow Section 5, photo was retaken September 2010. Floodplain and channel have elevated nearing terrace elevations, hummocks are present but diminished in form and have better vegetative cover and the local water table has also elevated assisting robust riparian vegetation development. Bare soil areas are less.
